CAMOUFLAGE DISPENSER, HELICOPTER MOUNTED

AAI Corporation

Army Land Warfare Laboratory

December 1972

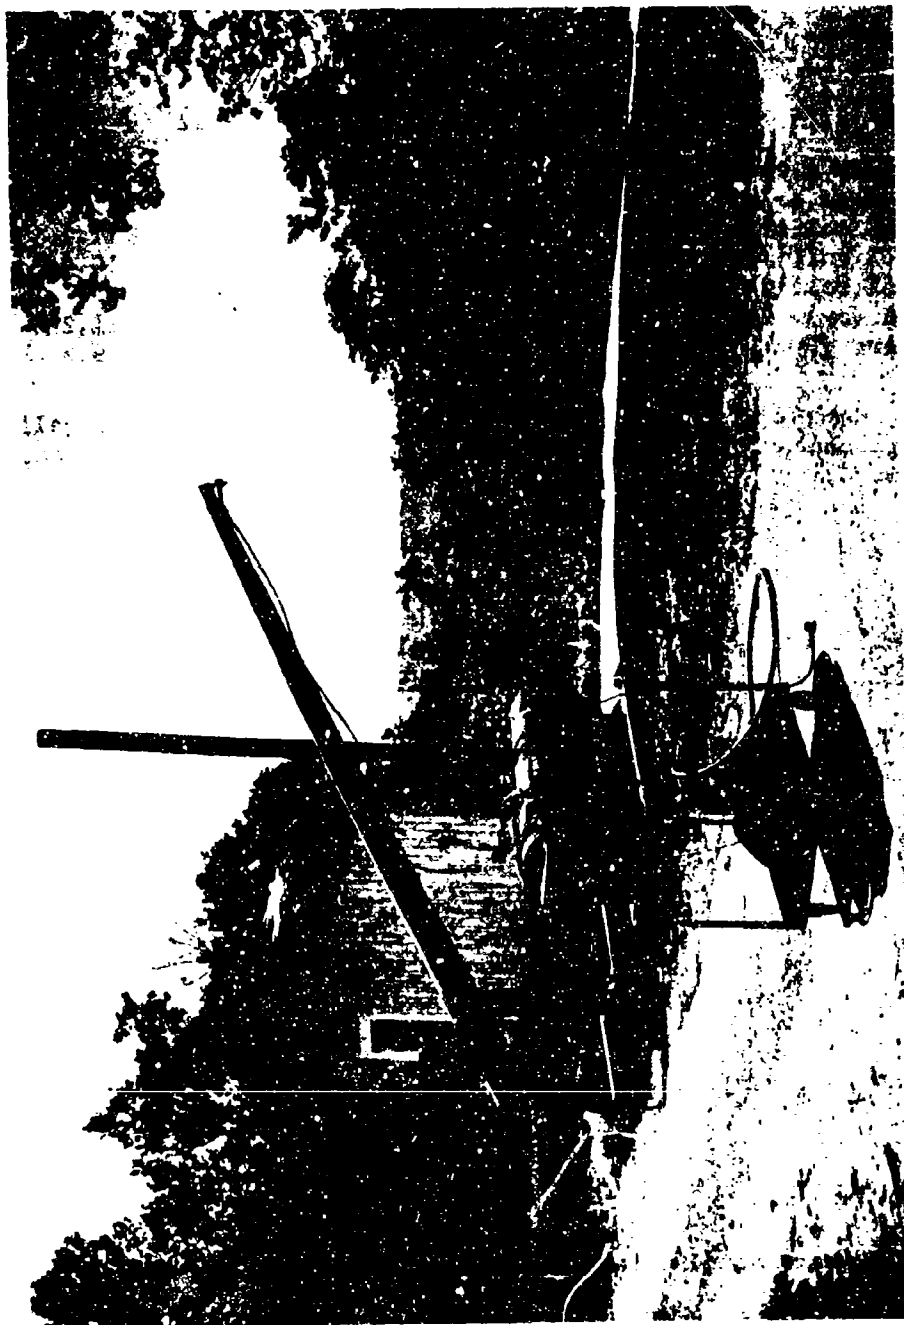
TEST STAND  
Figure 5

6.0.5 Figure 5 is a photograph of the test stand used during the initial tests.

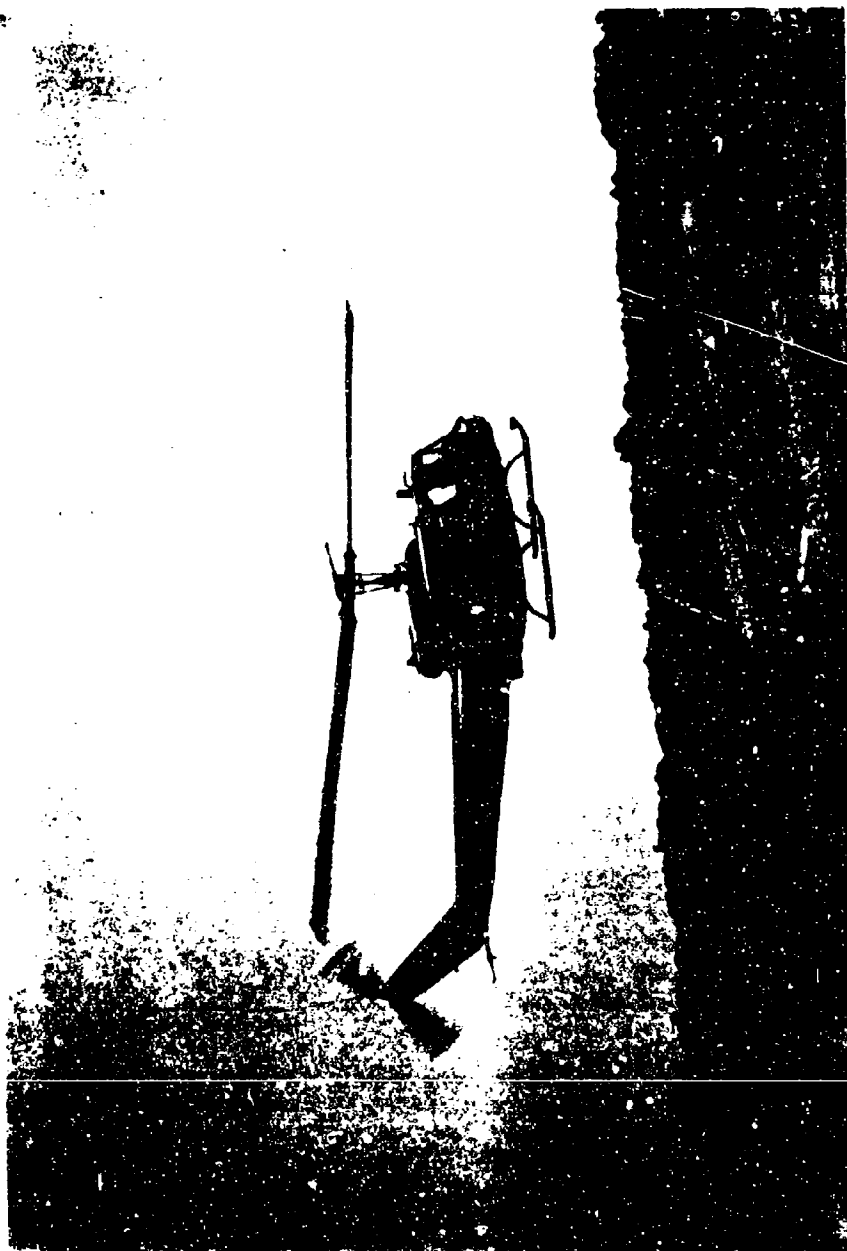
Figure 8

FLIGHT TEST AT ABERDEEN PROVING GROUND

7.0 Flight Tests at APG with 35% Solids Solution: On 8 June 1972 a flight, using Units No. 9 and 11 was conducted at Phillips Army Air Field, Aberdeen Proving Ground, Maryland (See Figures 6, 7 and 8).
